Research Project to Investigate Floating Booms for Containing Alligator Weed Following Treatment.

September 2002

Proponent: Port Stephens Council

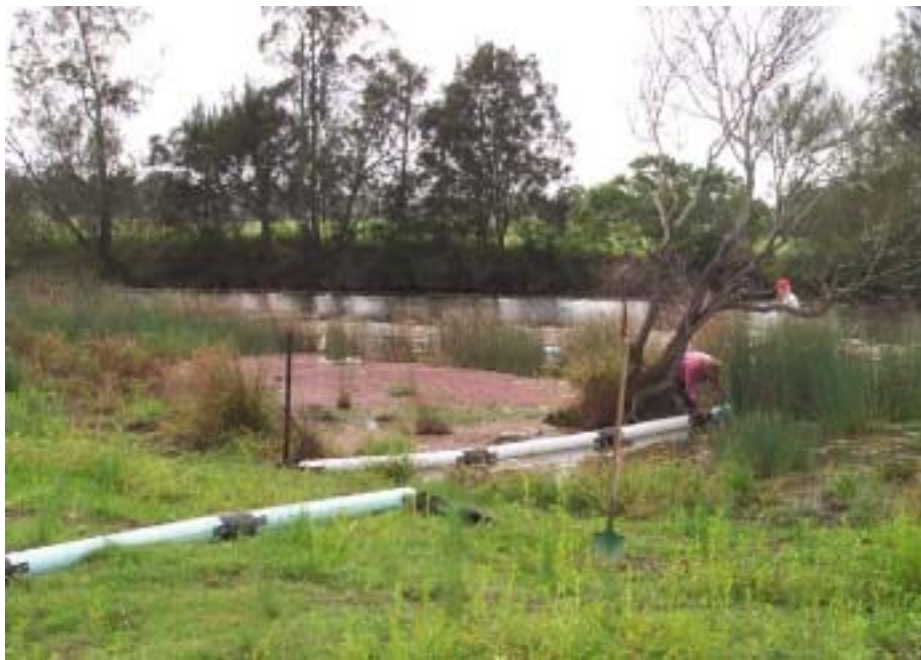
Installing floating Boom at the junction of Williams River and Tumbledown Creek.

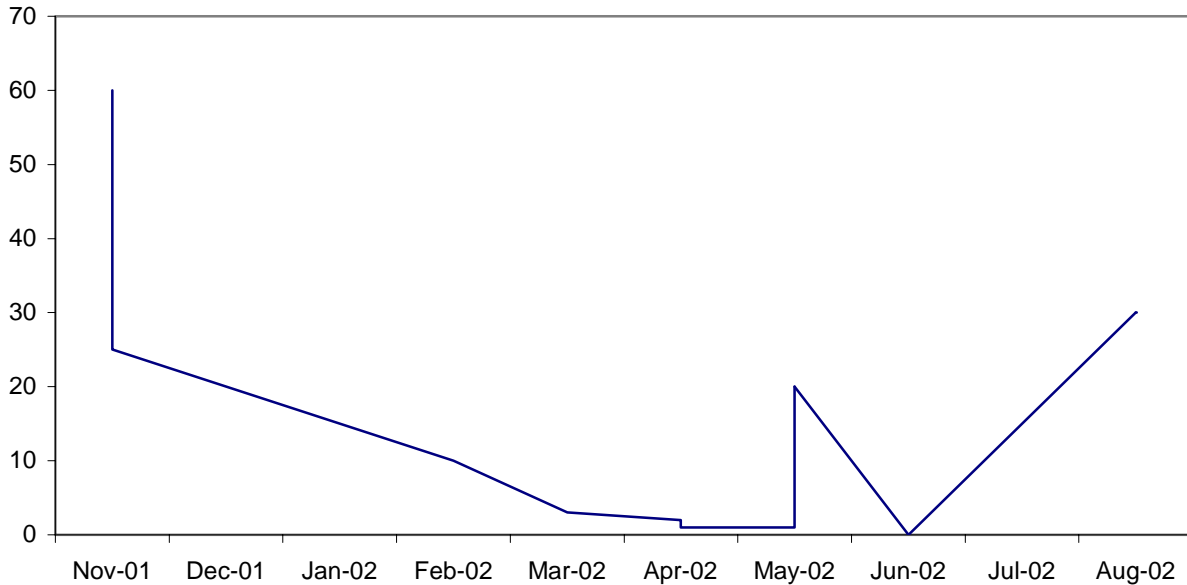
Figure 1.
Alligator Weed % Cover East Seaham I

This graph indicates that glyphosate application results in a substantial reduction in biomass. However, regrowth occurs and fragments remain viable. The upwards trend during the later stages of monitoring is a result of regrowth and viable fragments.

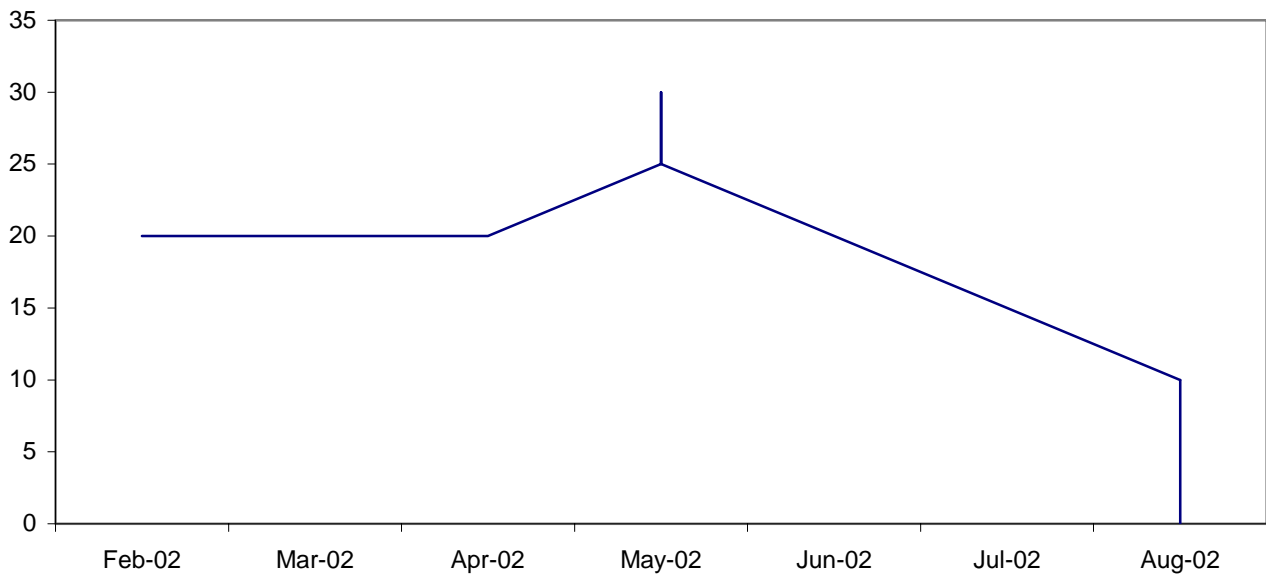
Figure 2.

Alligator Weed % Cover Paterson River

This graph shows the effect of Metsulfuron Methyl is slower following treatment and possibly that the first treatment was made less effective by an unknown factor. The end figure of 0 % cover is explained by the death of all above ground portions of Alligator Weed and that the fragments remaining are non viable, indicating Metsulfuron Methyl is more effective for Alligator Weed control than Glyphosate in aquatic situations.

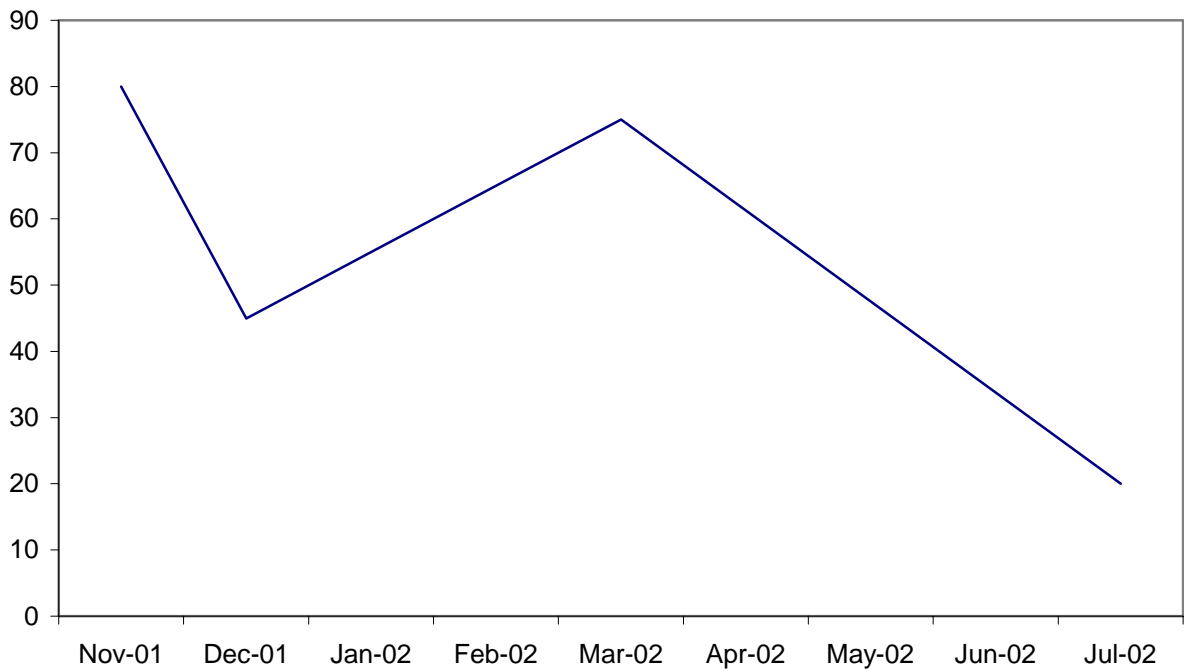
Figure 3.

Alligator Weed % Cover East Seaham II

This data shows the initial reduction in Alligator Weed resulting from the application of glyphosate is followed by a period of regrowth. The decline in cover towards the end of the monitoring is partly a result of winter conditions reducing regrowth.

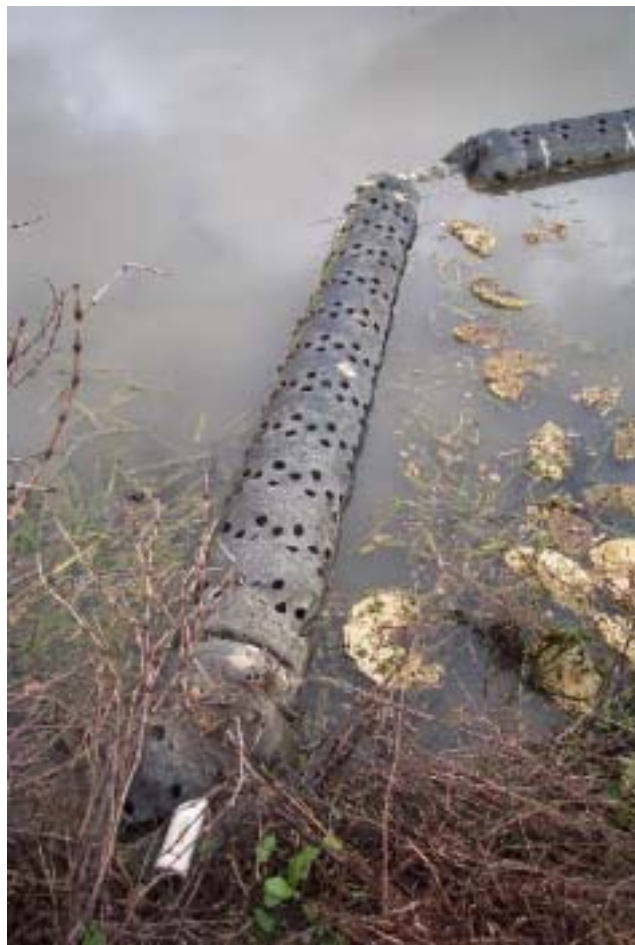
Figure 4

Wave reduction boom

The wave reduction booms are constructed of a 50mm PVC pipe core surrounded by rings of foam and covered in perforated rubber sheeting. Sections are 3m long and joined by short chains. The diameter of the booms is 30 cm (figure 4).

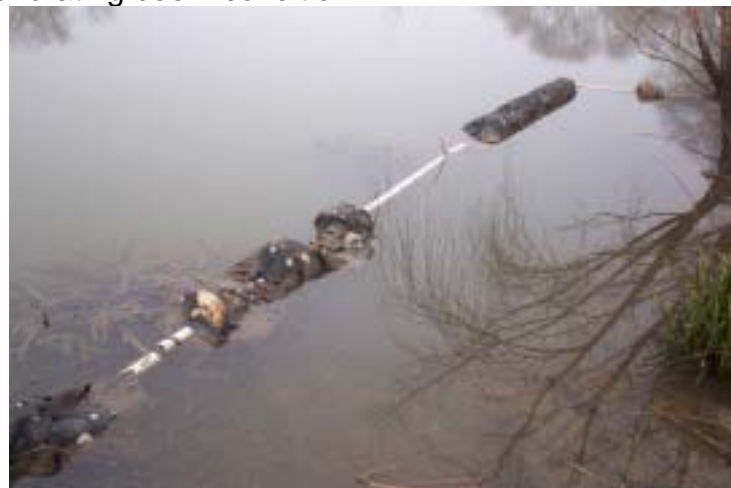
Figure 5

Deteriorating boom condition

The Paterson river site, August 2002.

During the course of the project the condition of the booms deteriorated (figure 3). The wave reduction booms were not economical to repair and new sections of specifically designed boom were purchased. The new sections are made of 150mm PVC pipe, linked by rubber straps. The joints are sheathed by short sections of rubber (figure 6). These booms are specifically designed to contain aquatic weeds. A total of 44 metres of boom was purchased. The booms have been anchored by attaching each end of them to several heavy concrete blocks. Both types of booms were manufactured locally by Pitbull PTY LTD.

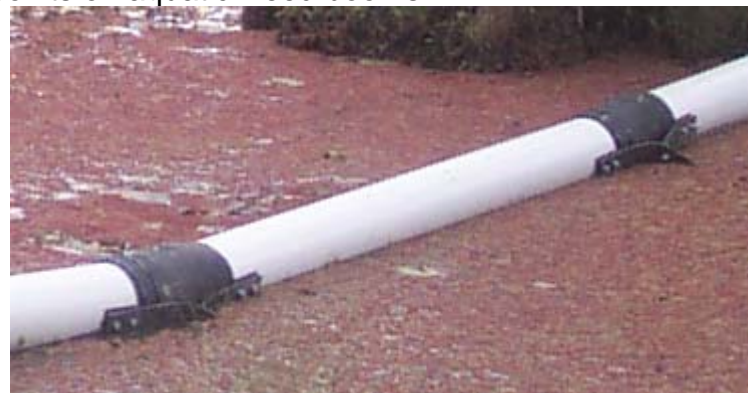
Figure 6

Joints on aquatic weed booms.
